# Characterization of tire fillers with Axia ChemiSEM

## A new and more efficient approach to failure analysis

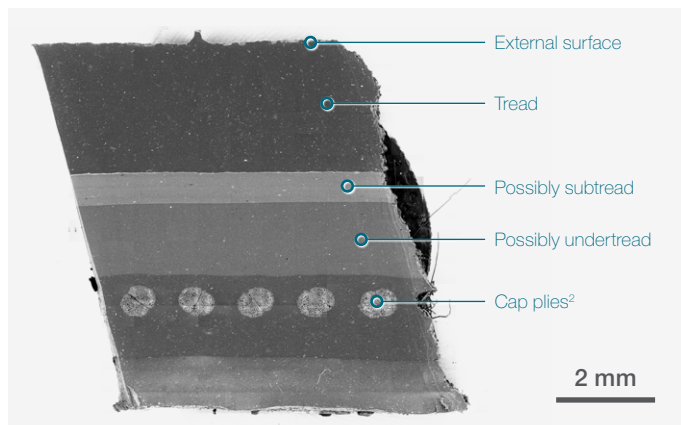
**Figure 1. 19x19 tiles montage. Tot acquisition time  $\approx$  15 mins. Acc voltage 20 keV, beam current 0.94 nA, Low vacuum (30 Pa).**

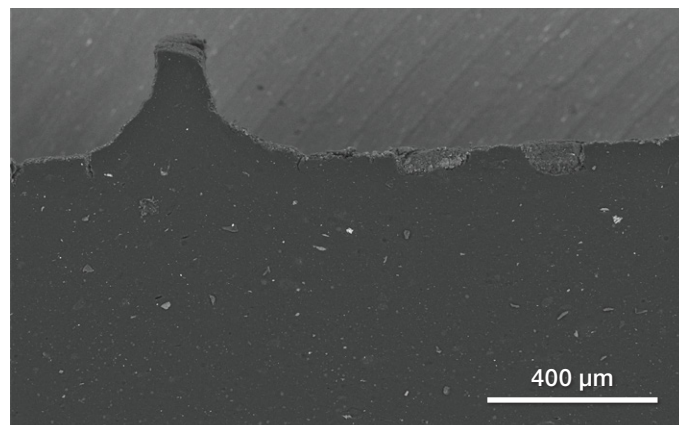
**Figure 2. Upper surface (tread). Acc voltage 20 keV, beam current 0.48 nA.**

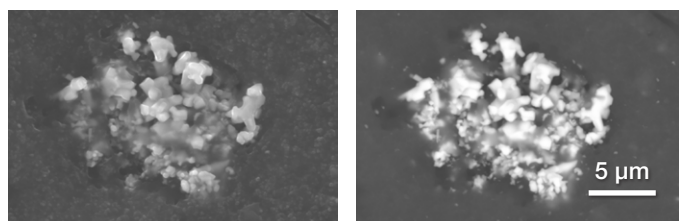
**Figure 3. Secondary electrons and backscattered electrons image of a Zn oxide particles cluster. Acc voltage 20 keV, beam current 0.48 nA, acquisition time 40 s.**

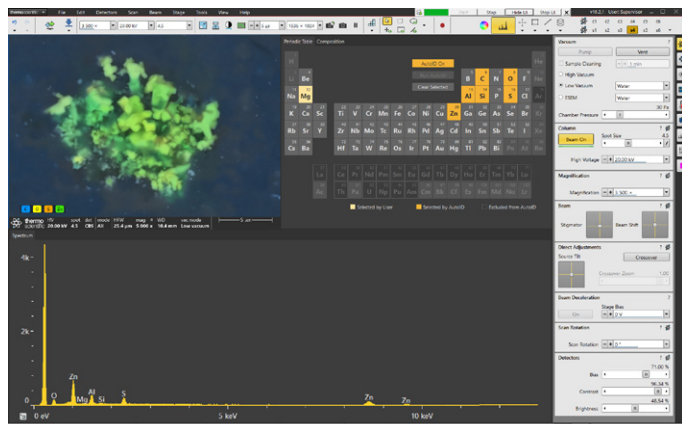
Figure 4. Axia ChemiSEM user interface with integrated live quantitative elemental mapping. It shows the quantitative elemental image during its acquisition, the spectrum of the area acquired, and the periodic table to select/unselect elements of interest.

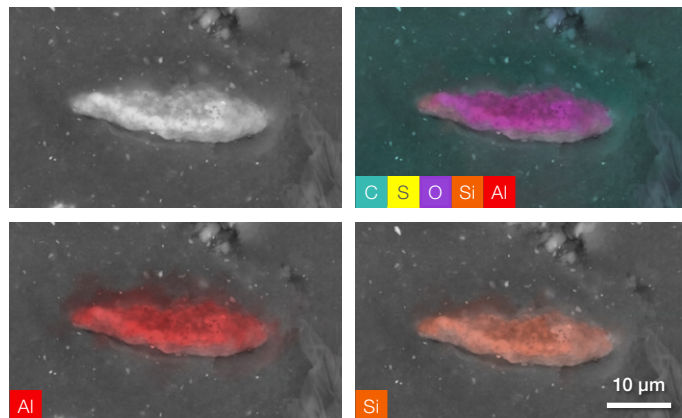
Figure 7. Backscattered electron image and a complete set of quantitative elemental images showing, in the upper right image, all the elements present in the ROI (including C, O and S). The last two images show Al and Si distribution on the particle. Acc voltage 20 keV, beam current 0.94 nA, acquisition time  $\approx$  100 s. To be noted, the elemental distribution and the related set of images have been obtained using only one image acquisition.

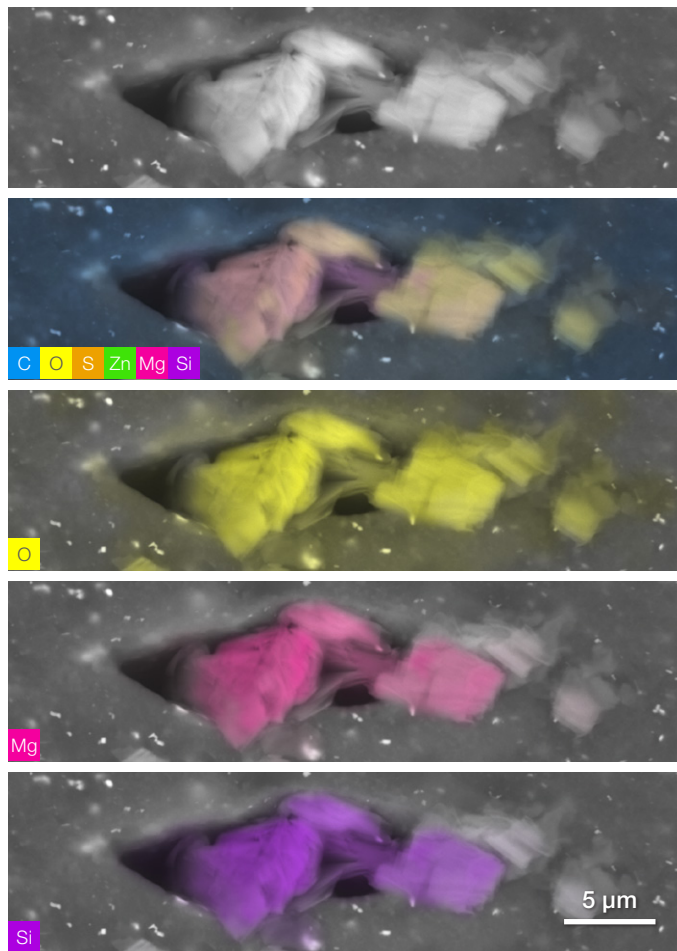
Figure 12. Oxygen, magnesium and silicon rich fillers. The set of images has been acquired in one time by simply saving the conventional greyscale image and then turning on the live quantitative elemental analysis and selecting or unselecting the different elements in order to highlight their distribution.
